# Manhole Inspection Summary

Manhole # S27K\_\_004MH

Insp Date: **6/3/08 9:03 AM**

**Location** Address: **855 S Poppleton St**

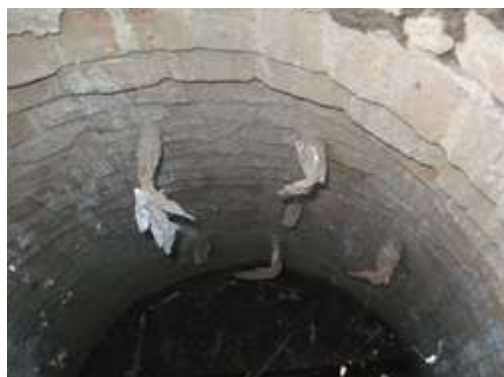
Defect 5

Count: **3** Missing: **3** ☒ **Corroded**

corroded rungs

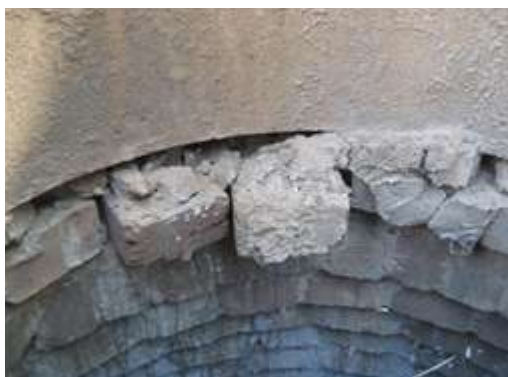
Defect 4

Condition: ☐ Sound ☐ Cracked ☒ **Leaks**

frame leaks, chimney loose bricks & infiltration

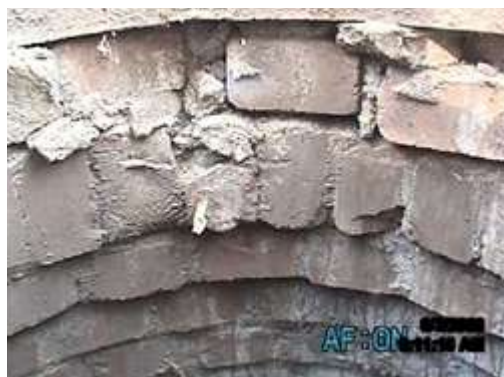
Defect 3

Condition: ☐ Sound ☐ Cracked ☐ Root Intrusion ☒ **Loose Brick** ☒ **Deteriorated**

Infiltration: ☐ None ☐ Joint ☐ Cracks ☒ **Mortar** ☐ Roots ☐ Wall

missing mortar, loose bricks in chimney

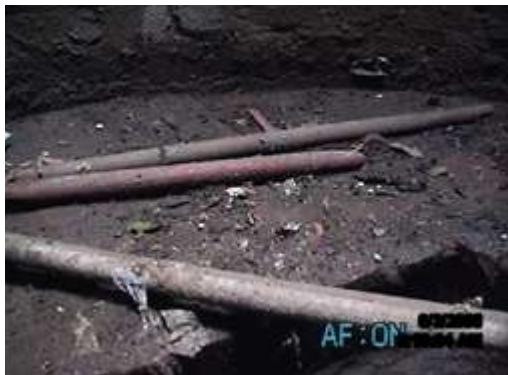
### Defect 1

Condition: ☐ Sound ☐ Cracked ☐ Root Intrusion ☐ Deteriorated ☐ Leaks ☒ **Debris**

debris on bench
